ST JOHN-IN-BEDWARDINE CHURCH TOWER APPEAL

Tower Work Progress 7th April 2011

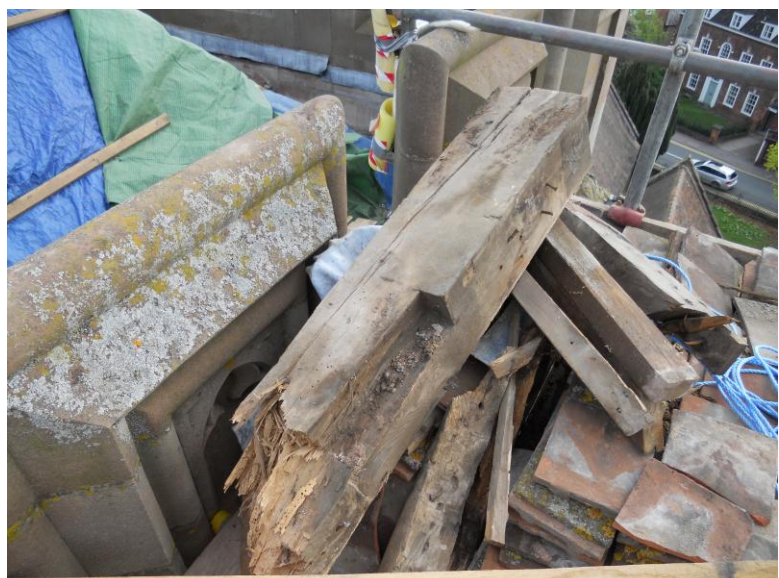
The rotten wood
is removed. This
is death-watch
beetle damage...

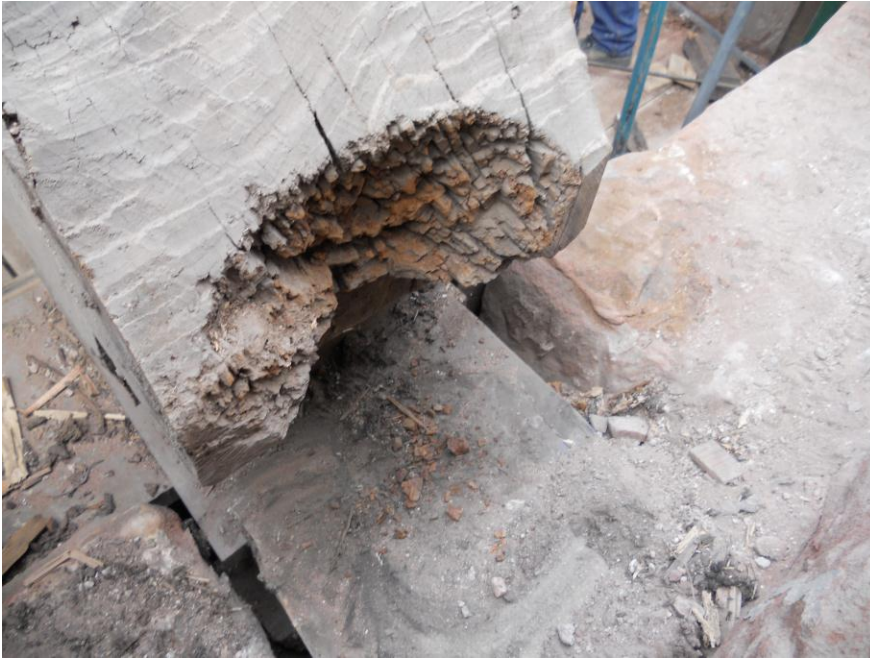
... and this is
wet rot.

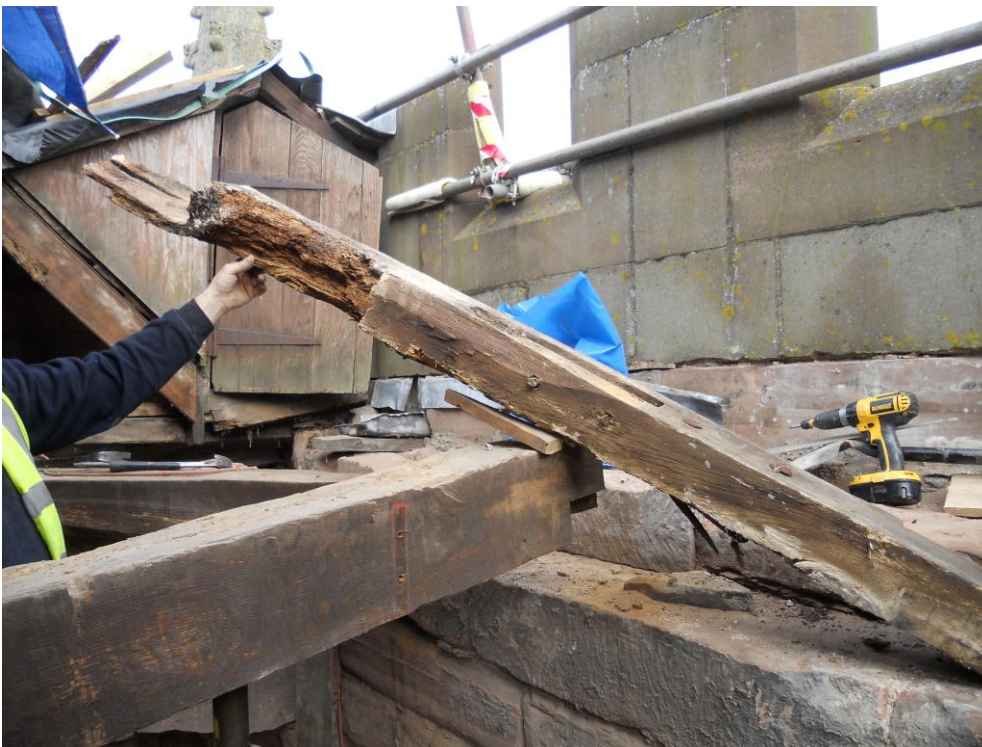
Woody finds more rotten timber.
The whole wall plate and timber sub-structure will
need to be replaced.

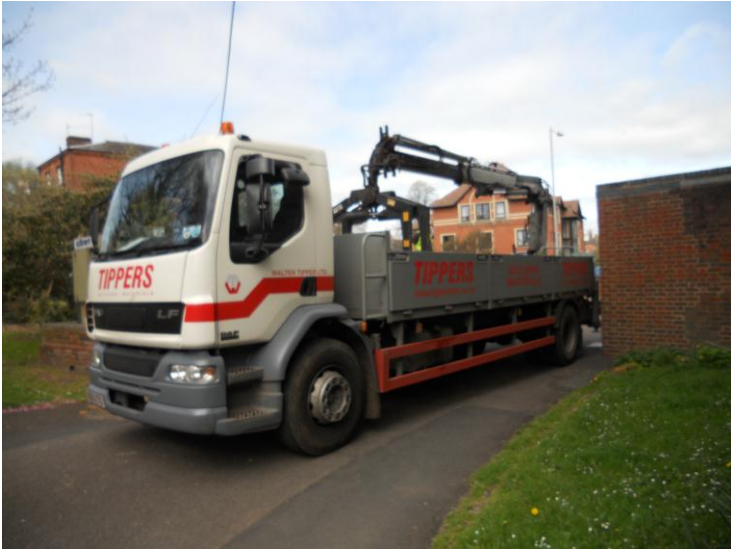
Here comes the new timber!

The stout beams for the new wall-plate are hoisted to the tower roof.

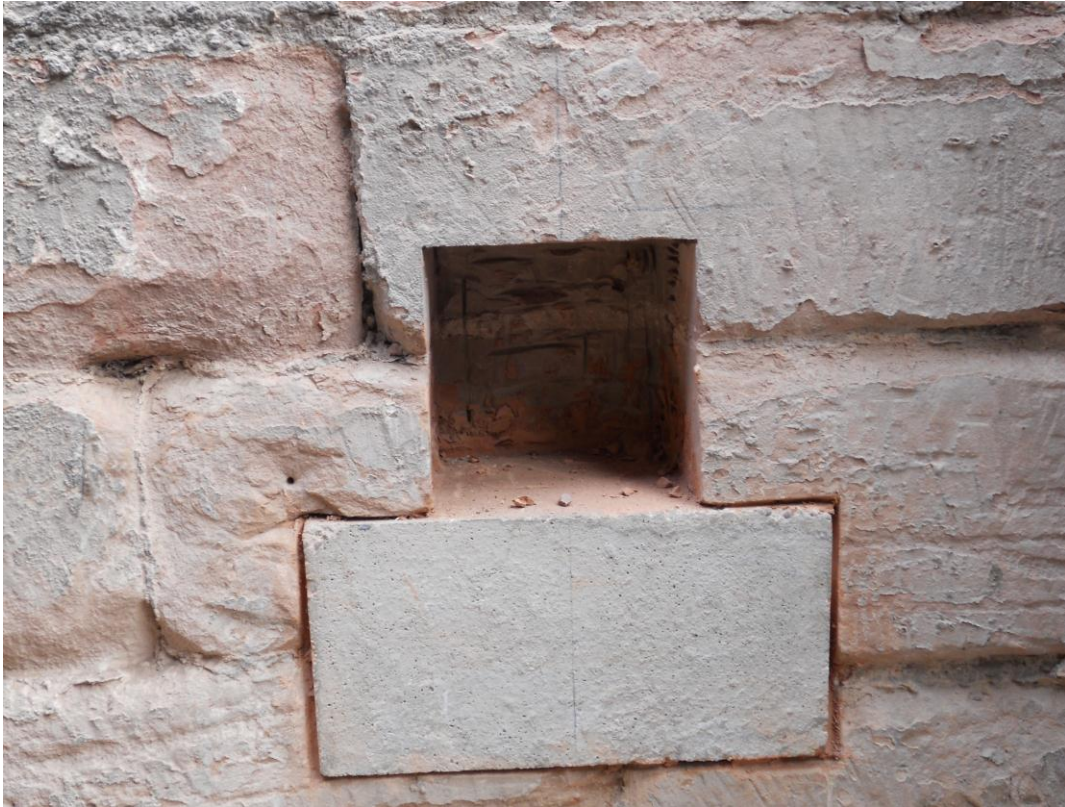
The stonemason has cut a hole to take the new steel support, which is to hold up the main roof beam.
